Subject: VARIABLE VALVE TIMING (VVT) NOISE WHEN STARTING ENGINE	Bulletin No: 01-002/08
	Last Issued: 01/16/2008

This bulletin supersedes the previous bulletin 01-043/07 issued on 11/29/07. The REPAIR PROCEDURE and PART(S) INFORMATION have been revised.

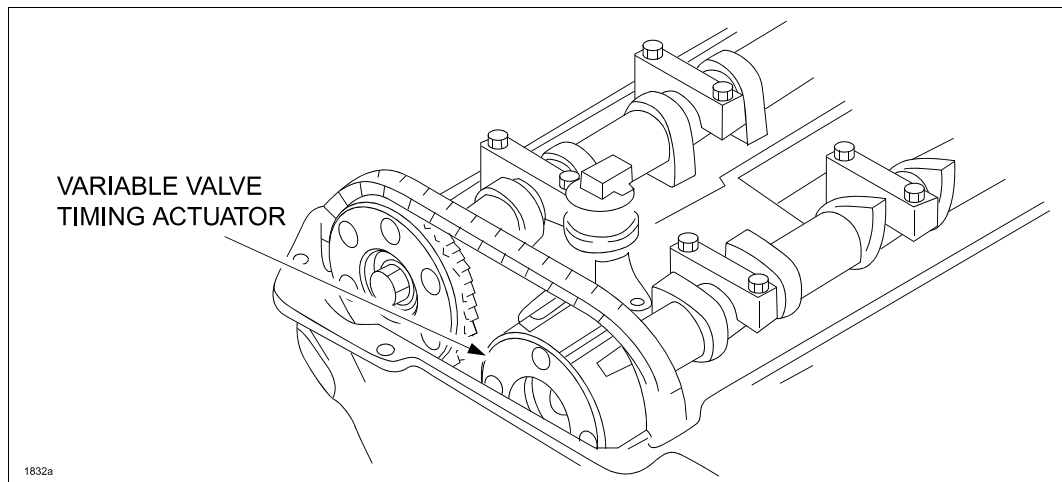
When the engine is first started, some vehicles may exhibit a loud ticking noise from the variable valve timing (VVT). This is caused by the lock pin of the variable valve timing actuator not fully engaging. Heat treatment has now been added around the hole of the variable valve timing rotor lock pin to prevent this from happening.

1. Verify customer concern.
2. After the engine cools down, replace the variable valve timing actuator. Refer to VARIABLE VALVE TIMING ACTUATOR REMOVAL INSTALLATION [L3 WITH TC] on MS3 or in the Workshop Manual section 01-10. Also, you may refer to the Training job aid "Engine Timing Verification and Correction LF 2.0L and L3/L3T 2.3L" on MS3.
3. Change the engine oil (5W-30) only, then start and let the engine idle for 5 minutes. This is to remove contaminants from the engine.
4. After the engine cools down, change the engine oil (5W-30) and filter.
5. Verify repair.
