Subject: REAR BRAKE GROAN	Bulletin No: 04-004/08
	Last Issued: 3/14/2008

2007-2008 CX-7

2007-2008 CX-9

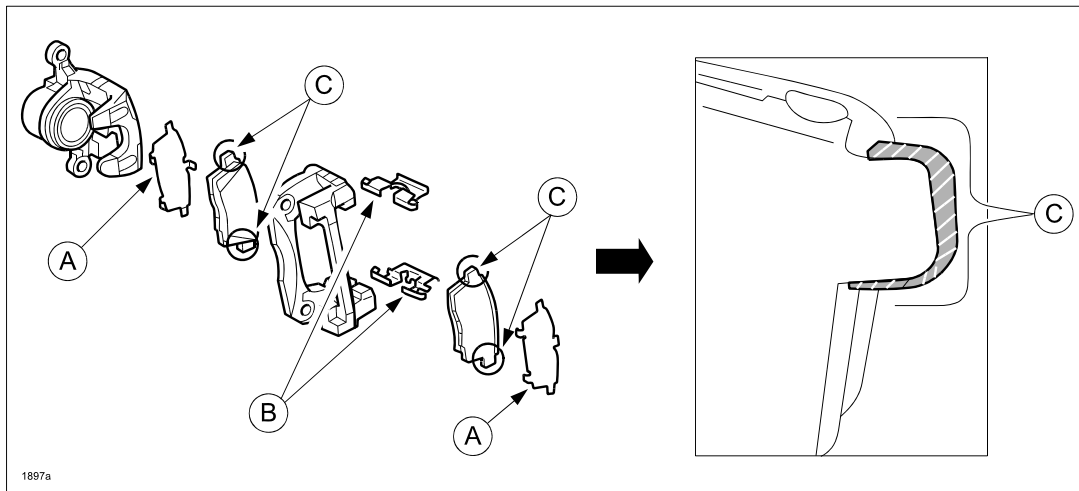
Some vehicles may exhibit a groan noise from the rear brakes when applying the brakes.

- The modified rear disc pad set comes with new brake pads, shims (A) and guide plates (B) to be installed.
- Prior to installing modified disc pads, lightly and evenly apply white grease to the disc pads in the locations shown (C).

- Use care not to get any grease on the disc pad-to-rotor surface or rotor. If grease comes in contact with the disc pad-to-rotor surface or rotor, clean grease using brake parts cleaner.
