Subject: FRONT BRAKES SQUEAK WHEN APPLYING BRAKES	Bulletin No: 04-001/08
	Last Issued: 1/16/2008

2007-2008 CX-7

2007-2008 CX-9

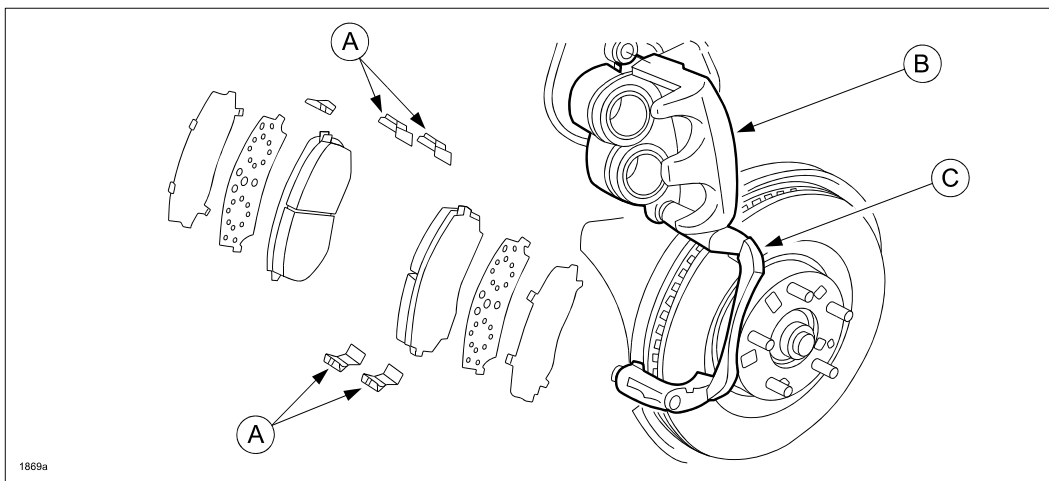
After parking in cold temperatures accompanied by a humid climate, some vehicles may exhibit a squeak from the front brakes during initial braking. This noise is caused due to deterioration of grease between the front disc pads, shims and the brake caliper.

When you encounter a customer complaint, replace the guide plates (A) with service parts, then apply white grease (provided with guide plates) to the location indicated on the caliper (B) and mounting support (C) according to the following procedure.

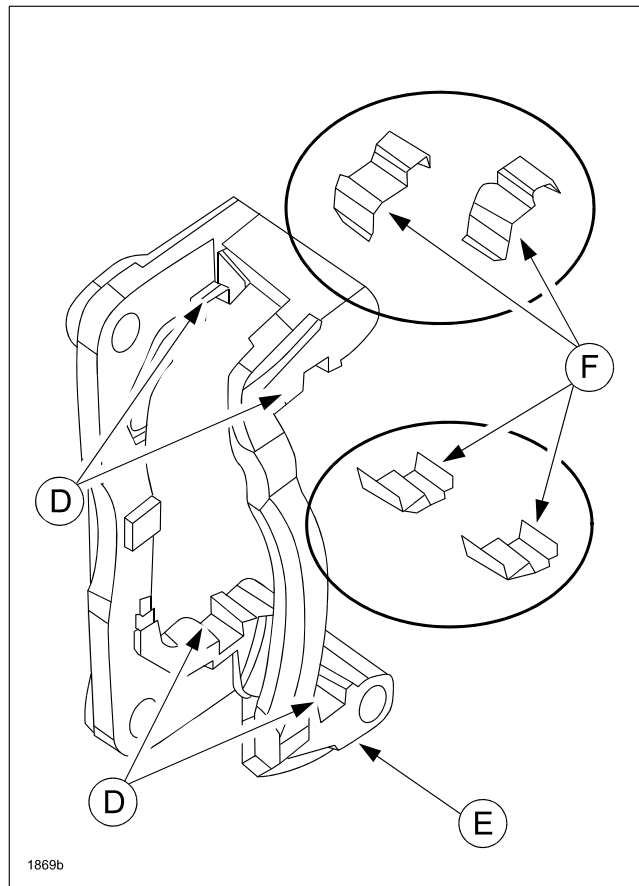
3. Clean the guide plate seating area (D) using brake parts cleaner or equivalent.

4. Peel off the backing sheet of the double-sided tape on the guide plate (F), then install the guide plate in the mounting support (E).

- DO NOT apply any grease on the guide plate seating area of the mounting support.
- If the double-sided tape of the new guide plate is damaged during installation, be sure to discard the guide plate and use a new one.

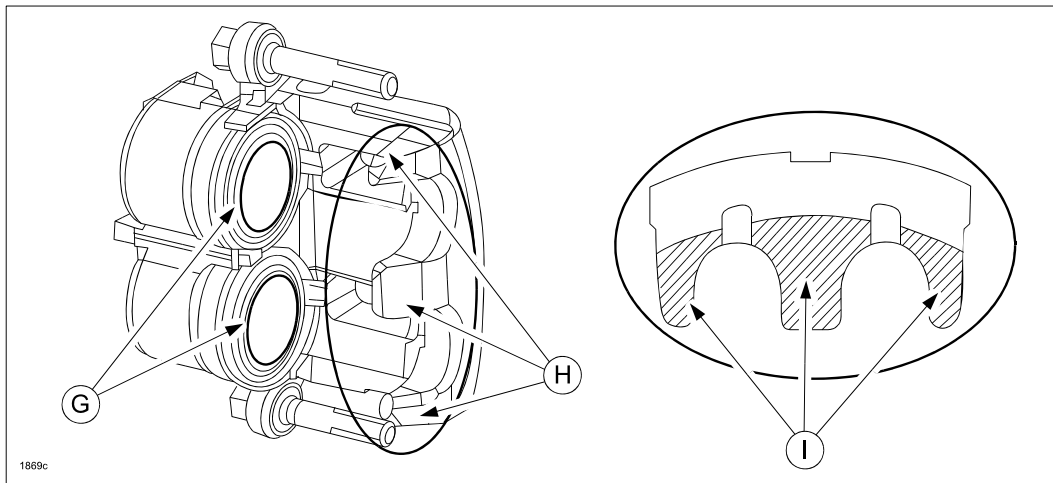
5. Clean the ends of the caliper pistons (G) and the caliper body (H, I) using brake parts cleaner or equivalent. Remove all shims from the disc pads and clean off black grease.

6. Lightly and evenly apply white grease (provided with guide plates) to the following:
 - End of brake caliper pistons (G).
 - Brake caliper body (I).
 - Pad-to-shim surface and between the shims (all shims).

- Use care not to get any grease on the disc pad-to-rotor surface or rotor. If grease comes in contact with the disc pad-to-rotor surface or rotor, clean grease using brake parts cleaner.
